LIGHTNING PROTECTION OF THE FOKKER 100 CFRP RUDDER.

A.J.M. Ruiter,  
Fokker Space & Systems B.V.,  
(formerly of Fokker Aircraft Corporation),  
Amsterdam,  
Holland.

ABSTRACT

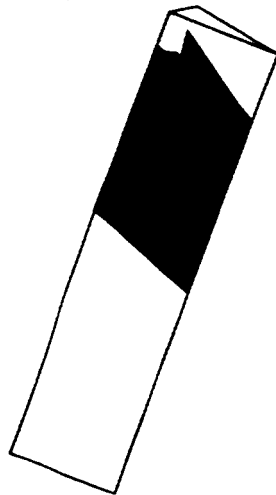
Figure 3.

Based on the above mentioned considerations it was decided to evaluate a trailing edge construction as shown in figure 3.

Test specimen 1 consisted of two CFRP sandwich skin panels connected at the trailing edge by means of a CFRP trailing edge member (figure 3). The specimen dimensions are representative for the Fokker 100 CFRP rudder at the location between the middle and upper hinge (figure 4). Due to the weight penalty caused by rivetting, the design office preferred to adhesively bond the trailing edge to both skin panels. In order to compare the effects of adhesive bonding and rivetting, the trailing edge of the test specimen was split into two sections. The upper section was adhesively bonded while the other section was rivetted (figure 5). The trailing edge was also extended for some distance in order to be able to make a connection to the lightning current generator. Furthermore the sandwich skin panels were fixed in the correct position by means of two dummy (PU) ribs.

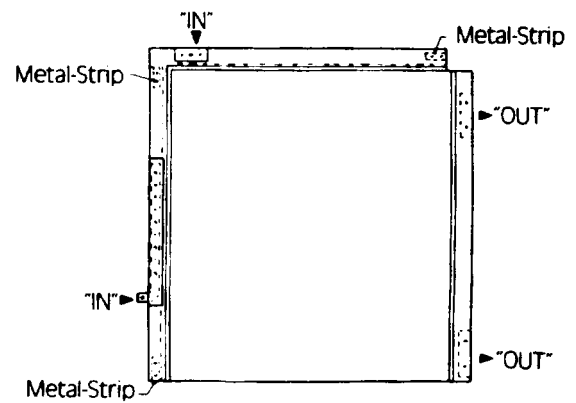
Figure 6.

Futhermore the test specimens were equipped with dummy front-spar flanges and rib-flanges (spigot area). See figure 6.
